**PHYSICAL STABILITY ANALYSE CONCERNING  
CAVNICULUI VALLEY TAILING DAMS**

**Ioan BUD, Ioan DENUT, Simona DUMA<sup>#</sup>**

*North University of Baia Mare, 62A Dr V. Babes street, Romania*

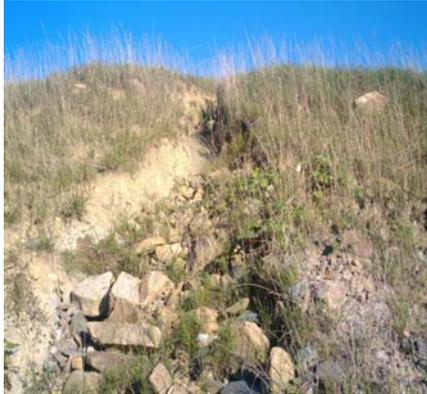
**Malaini tailing dam** is placed on the left side of the Cavnicului Valley, 3 km downstream of Cavnic city. It was functional between 1969 and 1973 and it's presented some instabilities. In the year of 2003 2004 the tailing dam constitutes the object of a project and an investment for stabilisation and environmental rehabilitation. The works were realised without respecting important rules for insuring long time physical stability and without taking care of specific meteorological condition. Even if in the area of the tailing pond no uncommon meteorological phenomenon was mentioned for now, some signs of tailing dam instability are visible (figure 1 and 2). The ravine phenomenon is very pregnant and visible short time after the rehabilitation. The soils deposited on the geo membrane are gone with water and this one is visible and starts to degrade. In the dam zone the slope is too important and the charge was realised with raw material which doesn't respect filter criteria (figure 3 and 4). This tailing dam was the first rehabilitation experiment but finalised with a failure.

**Fig. 1.** The ravine phenomenon

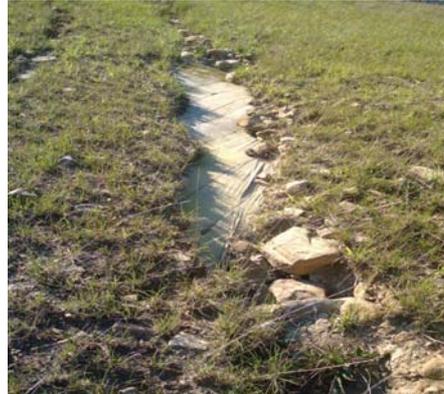
**Fig. 2.** The geo membrane visible

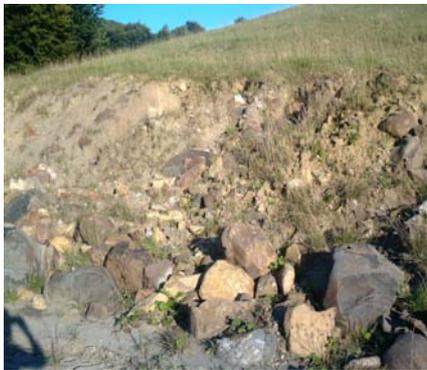
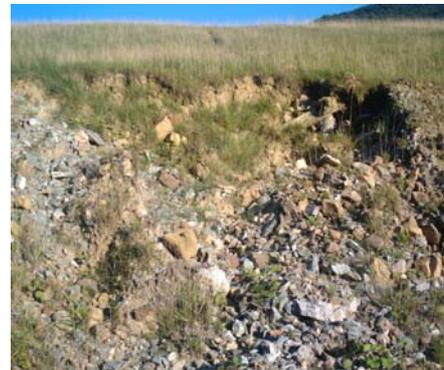
**Fig. 3, 4.** The starter dam instability
