## MINING RESIDUES AROUND LAKE OHRID

### Abstract

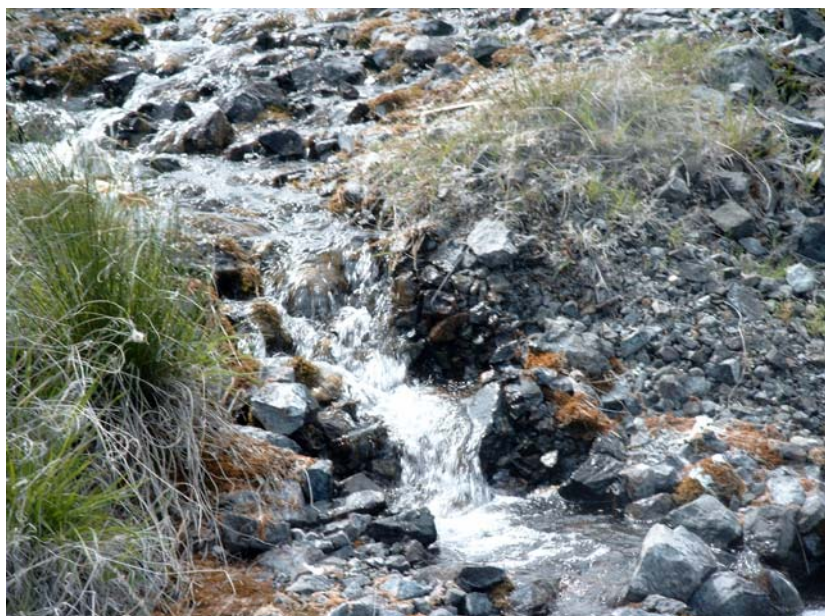
*Figure 2. Water flow from Pojska chromium mine*

The samples for the assessment of harmful and toxic elements in water, were taken in the outpouring of the waters, the so called "flowing channel" of the Guri i Kuq mine into the lake (sample no.4) Fig. 5, on the edge of the lake at the stockpile of slag at the train station (sample no.2) Fig. 4, in the water flowing at the stockpile of slag in Hudenisht (sample no. 3) Fig. 3, and in the flowing waters of Pojska chromium mine (sample no.1) figure 2.

As shown, the moss is an indicator of environmental pollution, where micro-elements like Ni, Cr, Pb and Zn are concentrated.
